DEPARTMENT OF TRANSPORTATION**DIVISION OF ENGINEERING SERVICES**

Contract #: 04-0120F4Cty: SF/ALA Rte: 80 PM: 13.2/13.9File #: 69.28**WELDING INSPECTION REPORT****Resident Engineer:**Pursell, Gary**Address:** 333 Burma Road**City:** Oakland, CA 94607**Report No:** WIR-002435**Date Inspected:** 14-May-2008**Project Name:** SAS Superstructure**OSM Arrival Time:** 2300**Prime Contractor:** American Bridge/Fluor Enterprises, a JV**OSM Departure Time:** 730**Contractor:** Zhenhua Port Machinery Company, Ltd (ZPMC), Changxing Island **Location:** Shanghai, China**CWI Name:****CWI Present:**

Bridge No: 34-0006**Component:** OBG**Summary of Items Observed:**

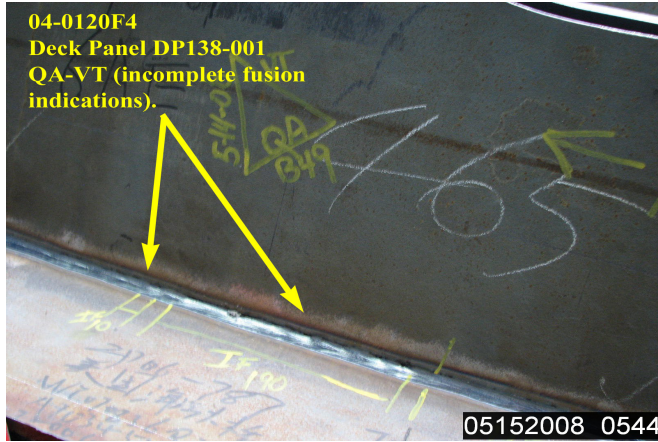
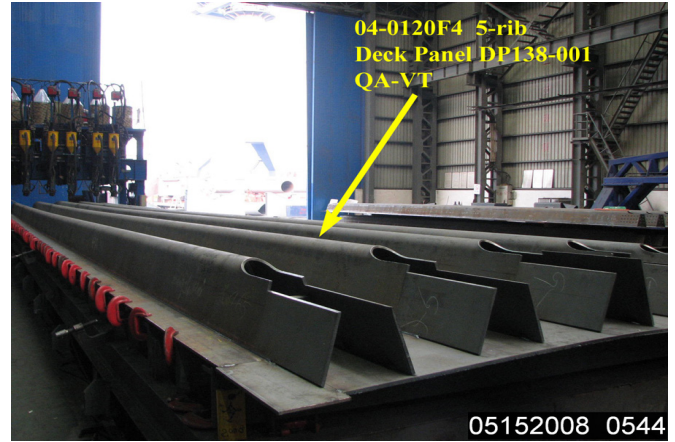
Item	Description	WBS	Dwg No.	Status
1	Deck Panel	NA	NA	QA-VT
<p>OBG Bay 1- Caltrans QA Inspector performed a Quality Assurance visual weld inspection on Orthotropic Box Girder (OBG) Deck Panel Assembly identified as DP383-001, partial joint penetration (PJP) welds 002 through 008 and DP435-001, PJP welds 002 through 009 joining u-ribs to deck plate. QA Inspector observed various defects which include oversize weld, overlap, underfill, undercut and incomplete fusion. The length and the location of each of these areas were recorded on the Caltrans QA Visual Weld Inspection Report for the Orthotropic Box Girder (OBG) and Deck Panel for tracking and distributed to the appropriate personnel for review. The following digital pictures illustrate deck panel DP138-001 and typical markings, identifying weld indications.</p>
